Re: Clean Water Act Compliance Evaluation Inspection

Enclosed is the report for the August 20-21, 2019 inspection of DCOR Platforms B and C, NPDES Permits CAG280000 and CAF001300 and CAF001157. Please provide written response to the Areas of Concern section of this report by December 9, 2019, as well as identify any factual disputes within the report. Email your response to Michael Weiss of my staff.

Inspection Date(s):	August 20, 2019 and August 21, 2019		
Time:	Entry, Exit: 11:05am, 1:30pm	Entry, Exit: 11:00am, 2:00pm	
Media:	Water		
Regulatory Program(s)	Clean Water Act NPDES		
Company Name:	Dos Cuadras Offshore Resources, LLC (DCOR)		
Facility or Site Name:	Platform C and Platform B		
Facility/Site Physical Location:	Platform C, Pacific Ocean Lease OCS-P 0241		
Geographic Coordinates:	LAT 34.332925, LONG -119.630767		
Mailing address:	290 Maple Court, Suite 290 Ventura, CA 93003		
Facility/Site Contact:	Jay Rao	Title: Environmental Engineer	
	Phone: 805-535-2078	Email: jrao@dcorllc.com	
Facility/Site Identifier:	NPDES Permits CAG280000 and CAF001300 and CAF001157		
NAICS:	211111 - Crude petroleum and natural gas extraction		
SIC:	1311		
Facility/Site Personnel Participating i

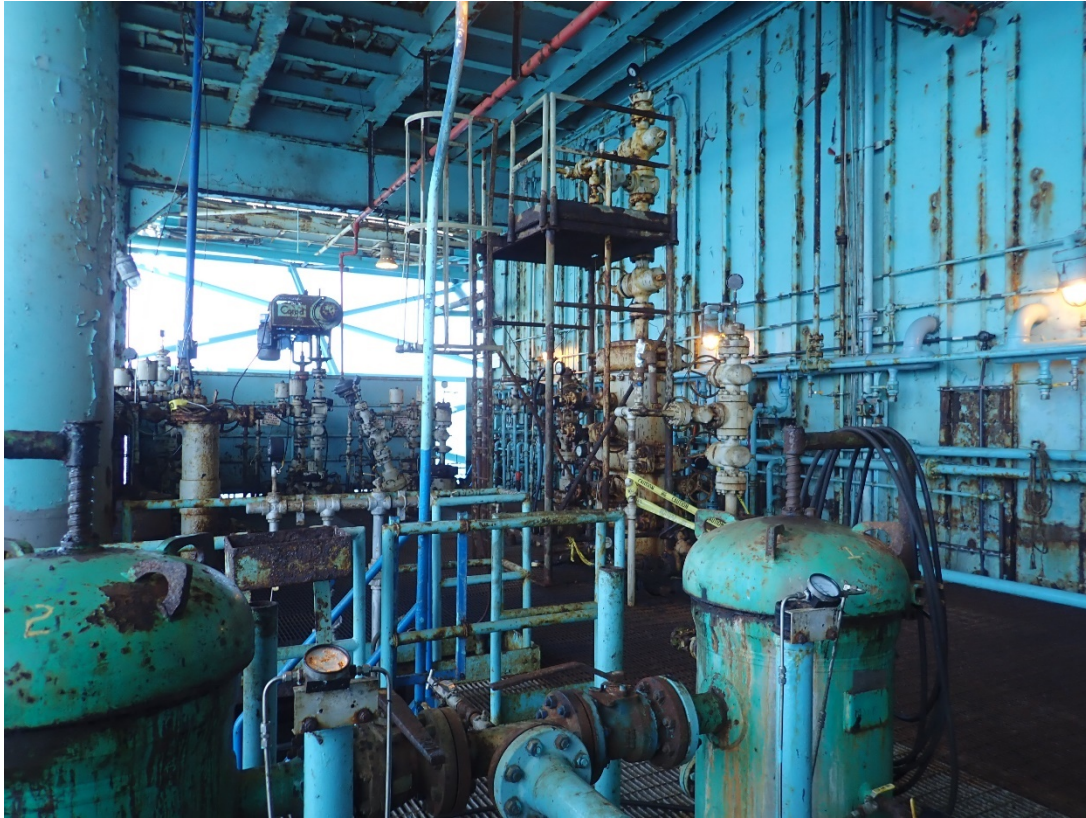
Photograph 1: Production Deck

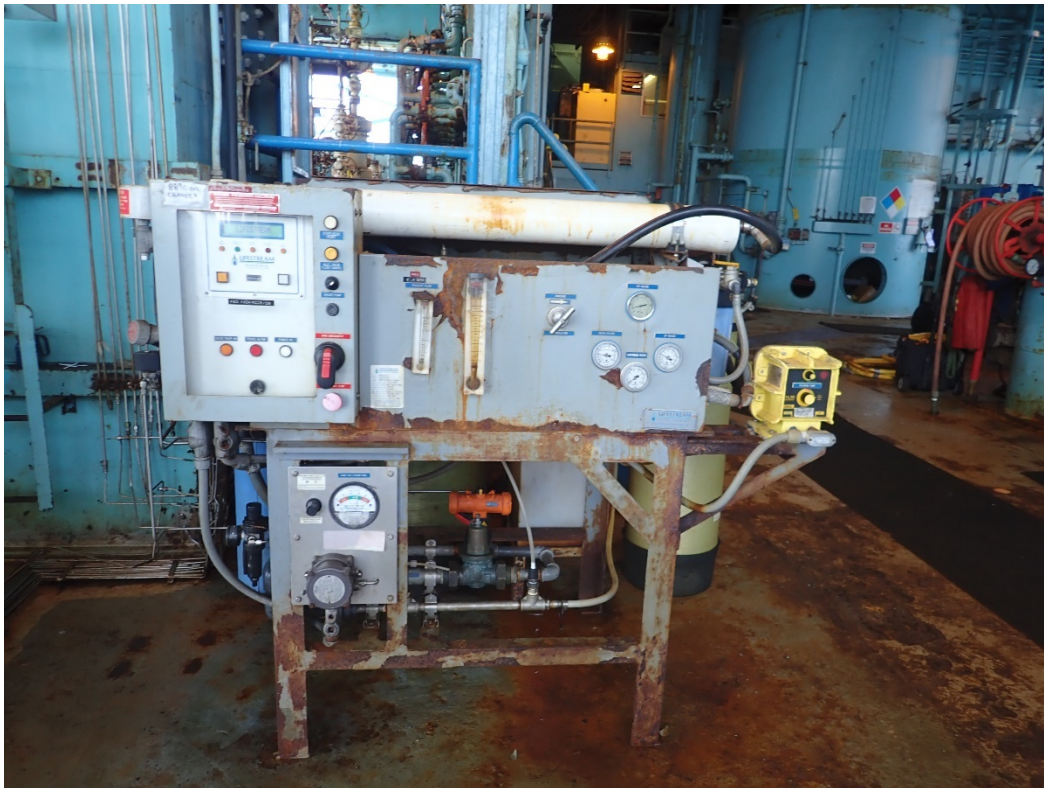
Desalination (i.e., reverse osmosis) unit wastewater (Discharge 007) is generated during the process of creating freshwater from saltwater. According to onsite Facility representatives, the desalination unit (Photograph 2) only provides water to sinks and showers at the Facility. The desalination unit wastewater is discharged without treatment and was actively being discharged at a high velocity (Photograph 5).

Photograph 2: Desalination reverse osmosis (RO) water treatment system

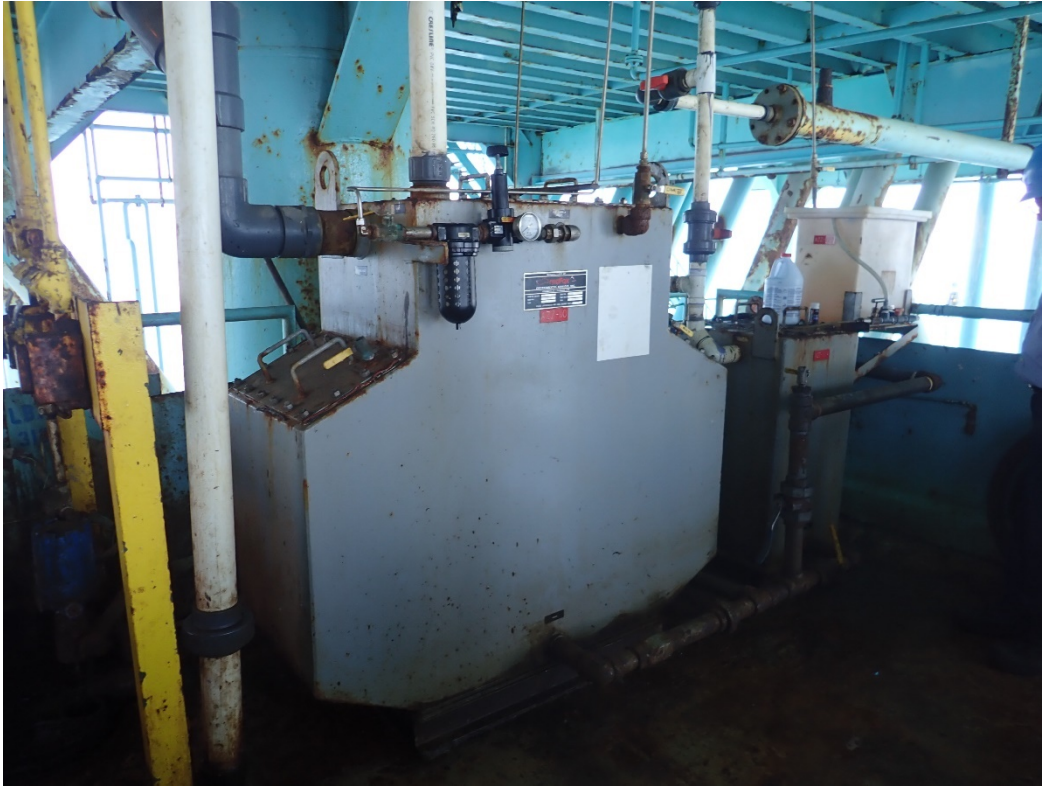
Sanitary Wastewater (Discharge 005) is treated onsite at the Facility with a redFox environmental marine sanitation device (MSD) Fox Pac Model No. RF-500-FP, which is United States Coast Guard (USCG) approved (Photograph 3). The treated water is discharged (Discharge 005) to the Pacific Ocean via a pipe (refer to Photograph 4). The onsite Facility representatives stated that the daily discharge water flow rate is estimated based on the number of people on the platform and the time spent per person. The MSD unit is sized for a maximum of 500 gallons per day (gpd).

Sanitary wastewater (Discharge 005) is the only wastewater stream to be treated onsite at Platform C. Discharge 005 is treated via a redFox MSD (Photograph 3). The self-contained treatment system is composed of an aeration chamber, flocculation, solids settling, media filtration, and disinfection. The Platform uses liquid bleach (sodium hypochlorite) for disinfection and checks the chlorine residual daily. Facility Representatives state the MSD is serviced annually by a contractor.

Photograph 3: RedFox Marine Sanitation Device

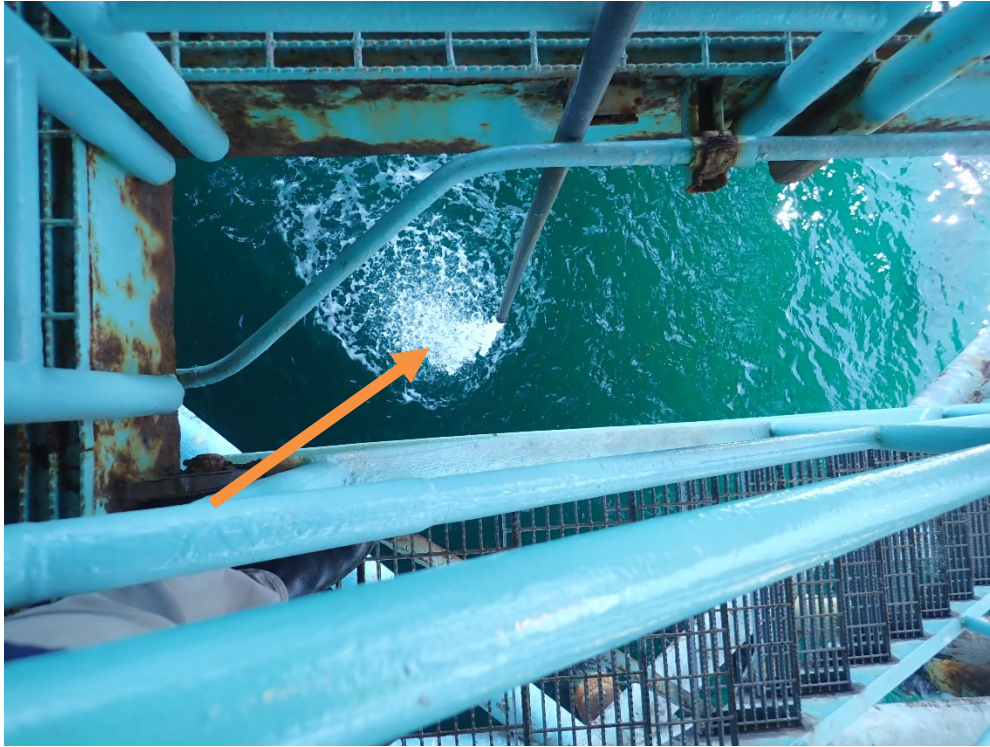
Photograph 5: Discharge pipe of RO reject

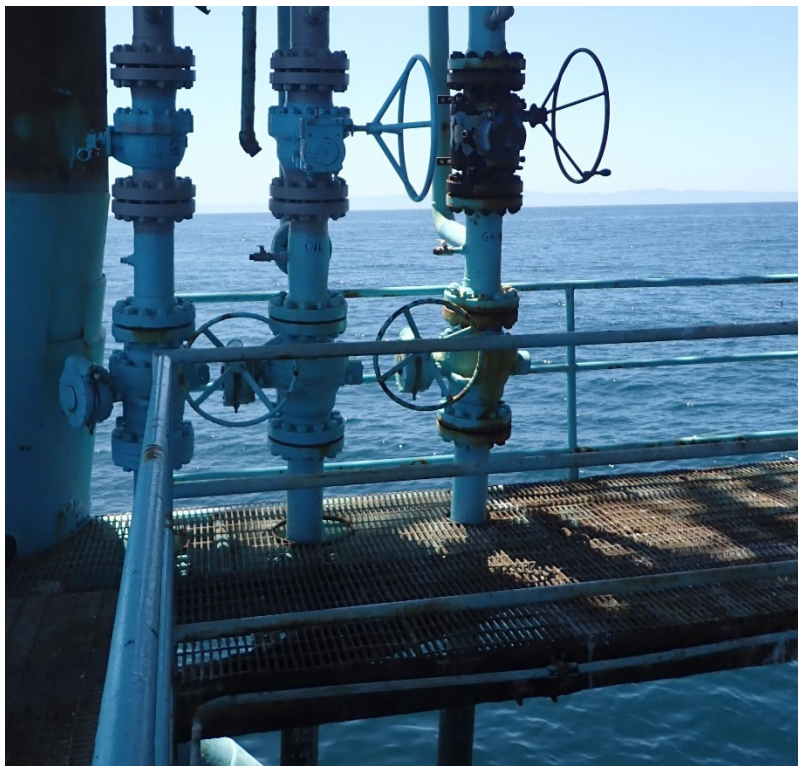
Photograph 6: Gross fluid, oil, and natural gas pipelines (from left to right) leaving the Platform

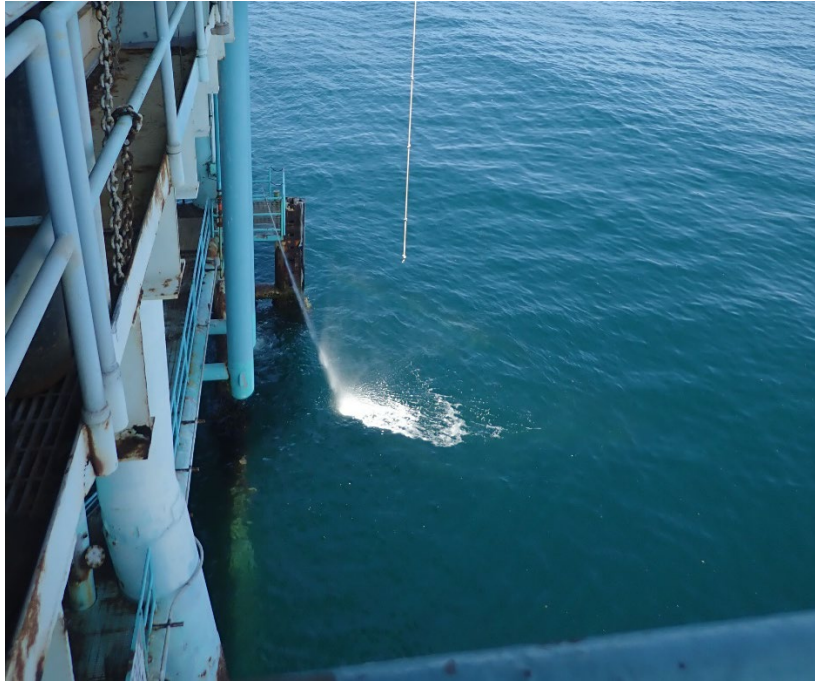
Fire control system water (seawater released during training, testing, and maintenance of fire protection equipment – Discharge 008) is composed of pure seawater that is constantly circulating throughout the Platform. The Fire control water is discharged without treatment and was actively being discharged at a high velocity (Photograph 7).

Photograph 7: Fire Control wastewater discharge

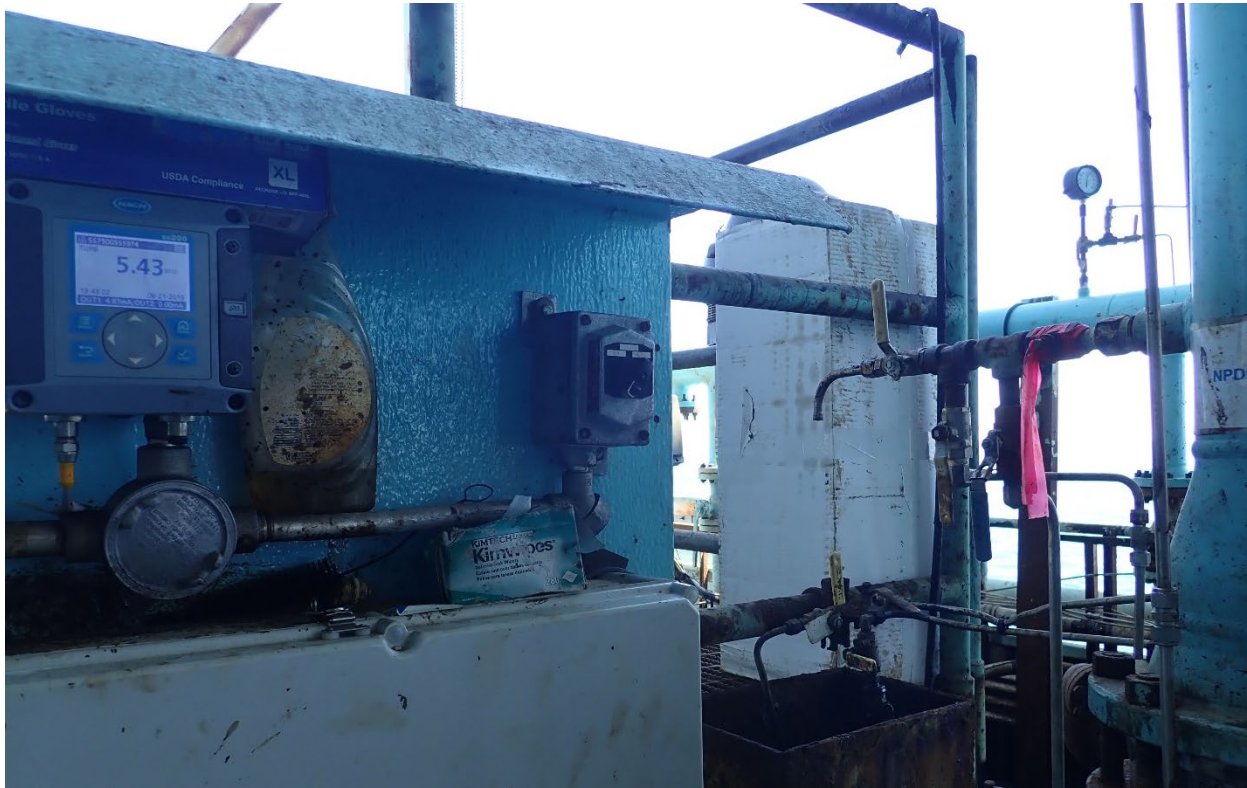
The Discharger conducts internal process monitoring for oil and grease in produced water after filtration via continuous inline turbidity measurement utilizing a HACH Surface Scatter 7 sc turbidimeter (Photograph 9). At the time of the inspection, we observed the continuous inline turbidity measurement of produced water to be 5.43 nephelometric turbidity units (NTUs). The Facility representatives stated that there is an alarm (visual and audible) that activates when the inline turbidity monitor exceeds 15 NTU and 20 NTU. The Facility representatives stated that these set points were to ensure the produced water (Discharge 002) did not exceed the monthly average and daily maximum oil and grease Permit effluent limits of 29 mg/L and 42 mg/L, respectively.

Photograph 9: Continuous inline turbidimeter on Platform B

1. There was rust and corrosion present throughout the Platform. While this is to be expected in a harsh marine environment, the Facility should ensure that the corrosion does not negatively impact that operations of the Platform and its ability to comply with the Clean Water Act.
2. The discharge from the MSD was cloudy and brown (Photograph 4). Facility Representatives stated the MSD is serviced annually by a contractor. Facility representatives should provide documentation for the last three years of MSD calibrations on Platform C and evaluate if there are any issues with the treatment unit.
3. Facility representatives should provide documentation for the last three years of inline turbidimeter calibrations on Platform B.

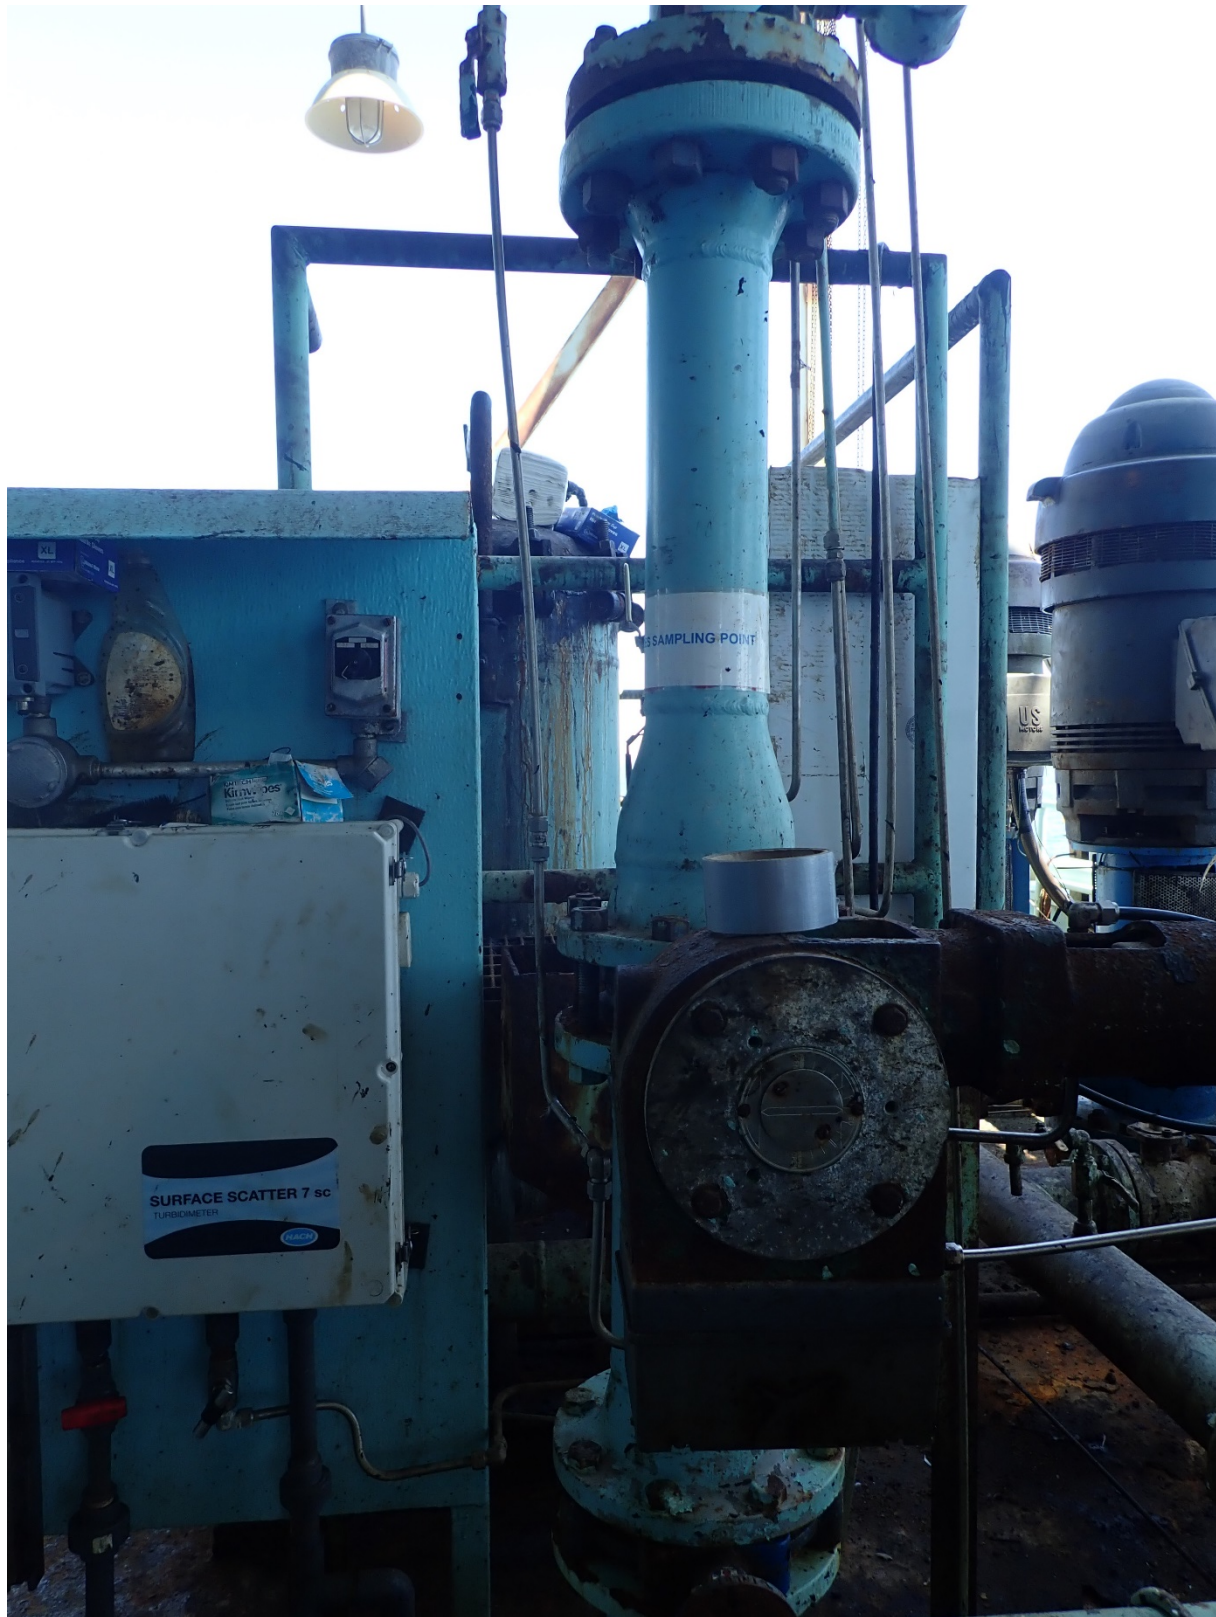
According to Facility Representatives, the pressurized treated produced water is then re-injected into the oil formation through approximately 11 water injection wells. If there is too much treated produced water to be injected, the produced water is discharged to the Pacific Ocean via a submerged outfall. The produced water (Discharge 002) NPDES sampling point is located after the turbidimeter near a diversion valve (Photograph 10). The inspection team did not witness the Facility take produced water effluent samples as the produced water was being re-injected.

Photograph 10: The produced water (Discharge 002) NPDES sampling point on Platform B
